PROPERTIES AND MICROSTRUCTURES OF HIGH-TEMPERATURE MATERIALS

Research Applications Division
Systems Research Laboratories, Inc.
2800 Indian Ripple Road
Dayton, Ohio 45440

August 1978

TECHNICAL REPORT AFML-TR-78-112
Final Technical Report for period 1 December 1974 - 31 March 1978

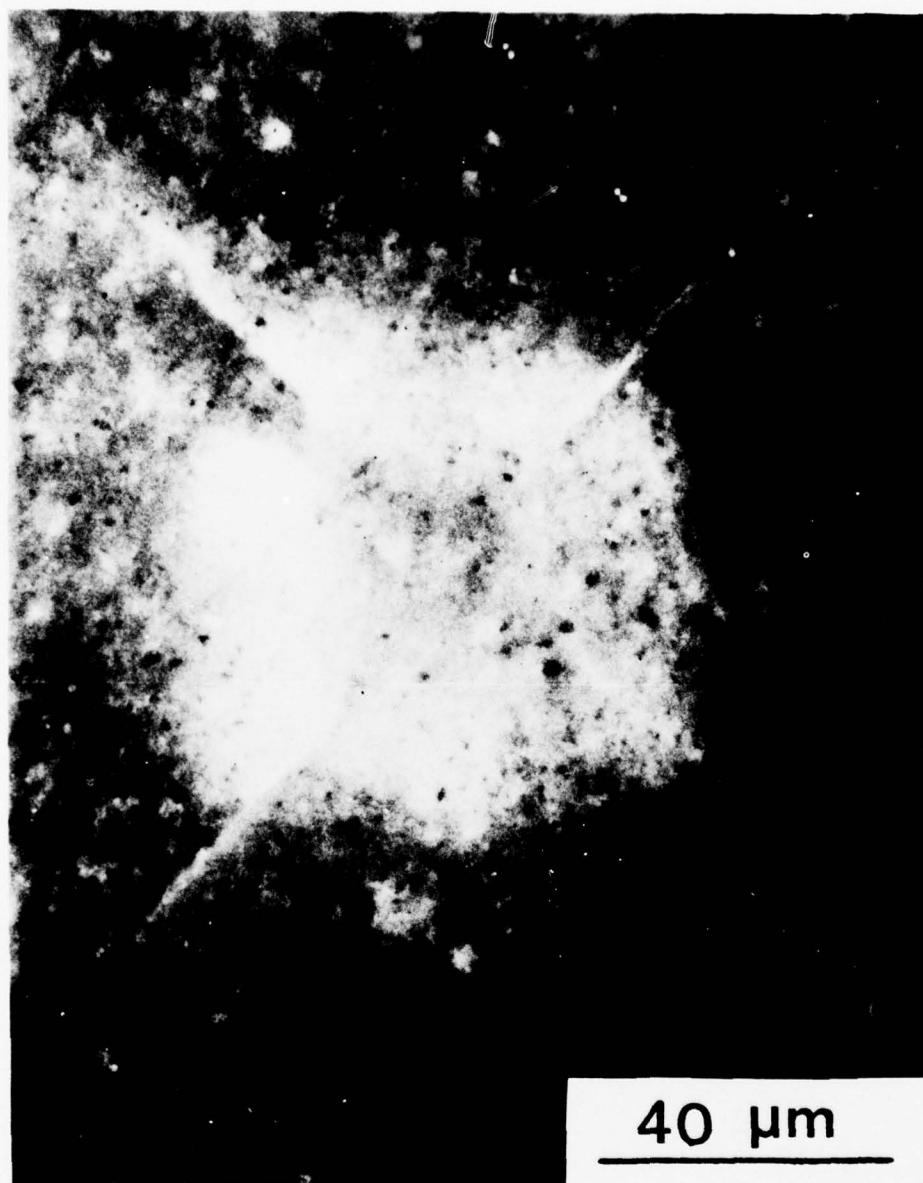
Figure 1. 2600-gm Diamond Pyramid Indentation in HP Si₃N₄
(a) Indentation on Polished Surface

Figure 1. (b) Crack Pattern after 8- μ m Surface Removal

Typical surface crack patterns around microhardness indentations are shown in Figs. 1 and 2, for a diamond-pyramid indentation and a Knoop indentation, respectively. On the surface, sharp cracks radiate from the corners of the diamond-pyramid indentation, while for the Knoop indentation a sharp crack is formed along the long diagonal.

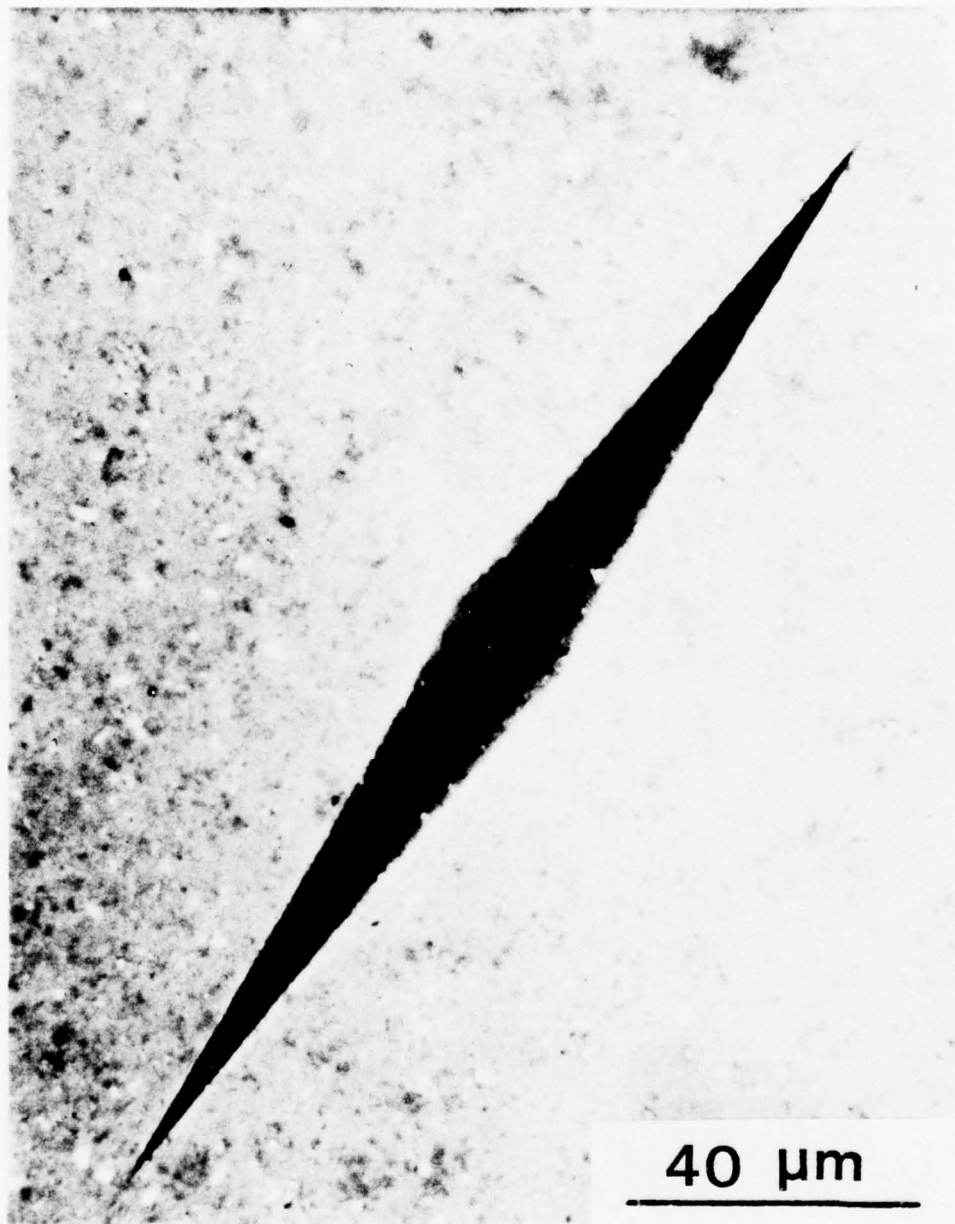
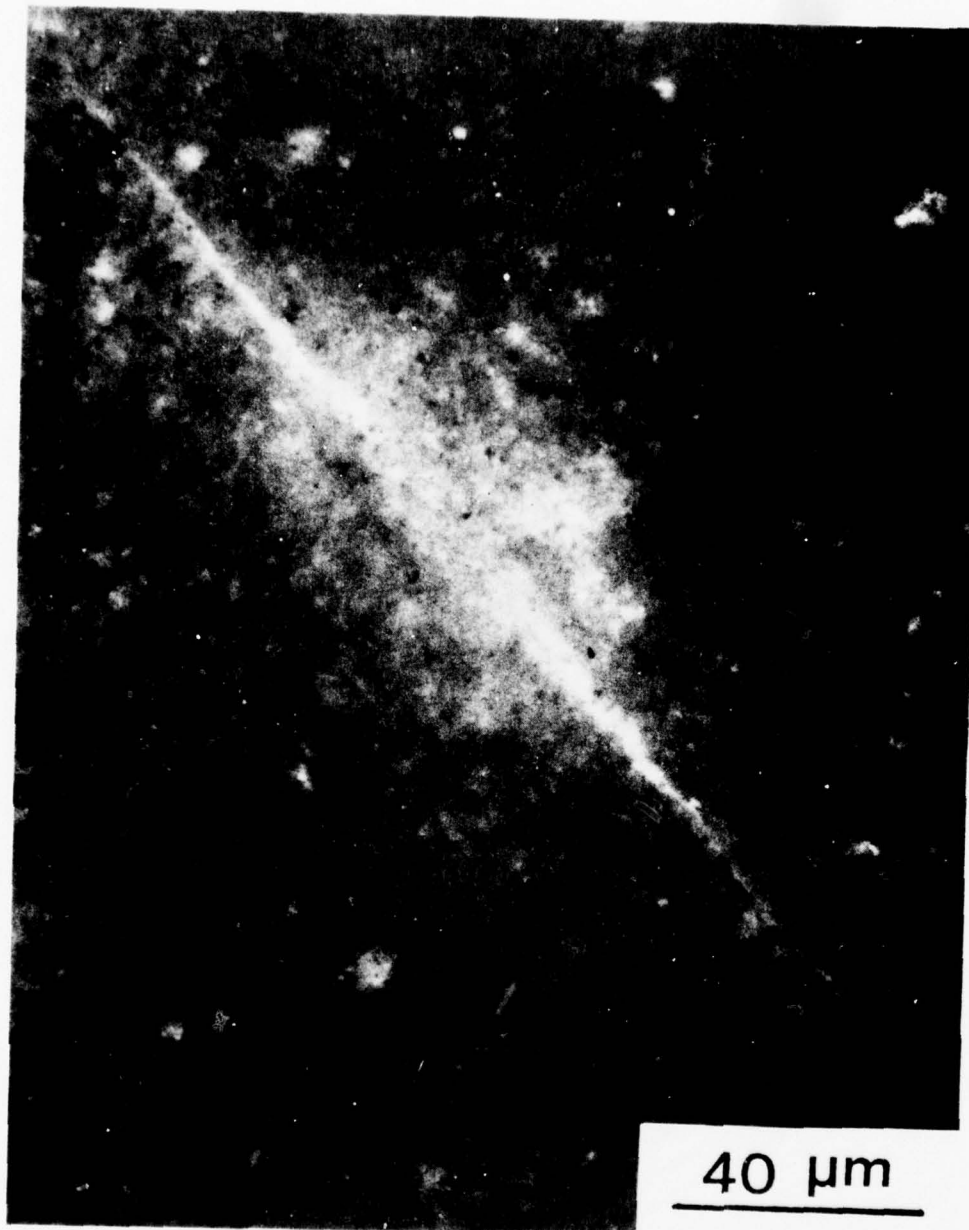
Figure 2. 2600-gm Knoop Indentation in HP Si_3N_4
(a) Indentation on Polished Surface

Figure 2. (b) Crack Pattern after 8- μ m Surface Removal

In the present effort, the use of flaws produced by Knoop indentations as opposed to diamond-pyramid indentations was preferred for the following reasons: First, with the Knoop indentation there is no crack perpendicular to the primary surface flaw as there is with the diamond-pyramid indentation. This is a more desirable situation from a fracture-mechanics-analysis point of view. Secondly, orientation of Knoop surface flaws is more convenient and can be controlled more easily since alignment is achieved by aligning the long axis of the Knoop indentation.

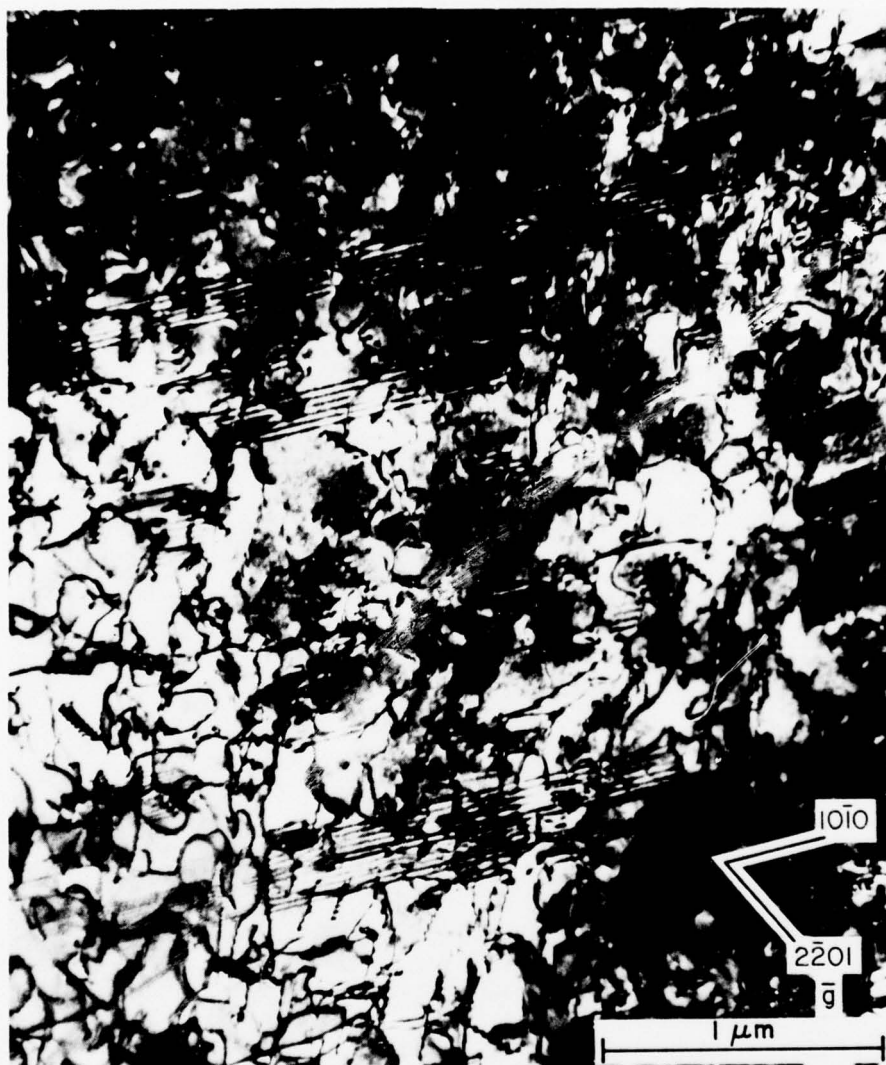
Figure 32. Stacking Fault in Creep Deformed $\text{Ti}_3\text{Al} + 10\ \text{wt}\% \text{Nb}$ (750°C , 45 ksi)

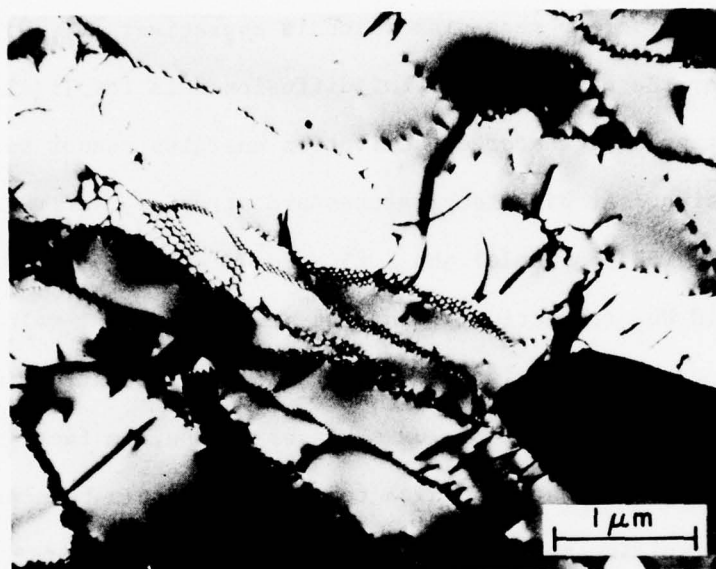
Figure 33. General Dislocation Substructure in
Creep-Deformed Ti₃Al (800°C, 20 ksi)
